# Manhole Inspection Summary

Manhole # S04II2022MH

Insp Date: **7/14/06 10:05 AM**

**Location** Address: **3222 NERAK RD**

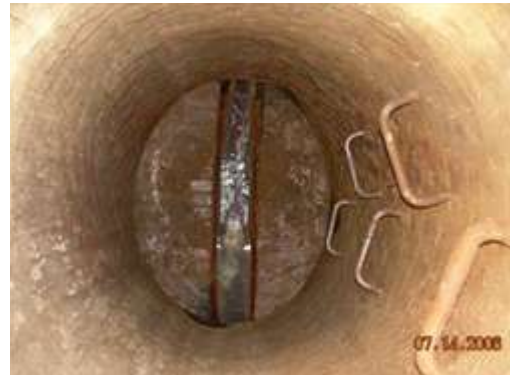
Top View

**Bench** ☒ Exists Material: **Brick** ☐ Parged ☒ **Debris** (not Condition related)

**Channel** Material: **Brick** ☐ Parged ☒ **Debris** (not Condition related)

**Steps** Count: **5** Missing: **0** ☒ **Corroded**

**Surcharge** ☒ **Evidence Of Surcharge** Depth: **1** (ft.) ☐ Active Surcharge Present

Evidence of surcharge - Bench debris.  
Channel debris. Corroded steps.

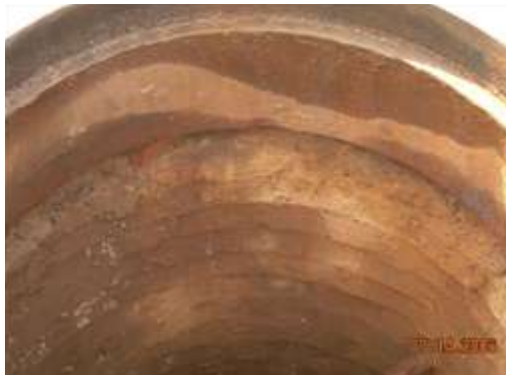
Defect

Comments **Inflow through the lid. The I6 pipe seal is not flush to the pipe. The I6 pipe shows Barrel infiltration.**

**Frame** Offset: **0** (in.) Condition: ☐ Sound ☐ Cracked ☒ **Leaks**

Frame and cover leaks. Adjustment  
infiltration.

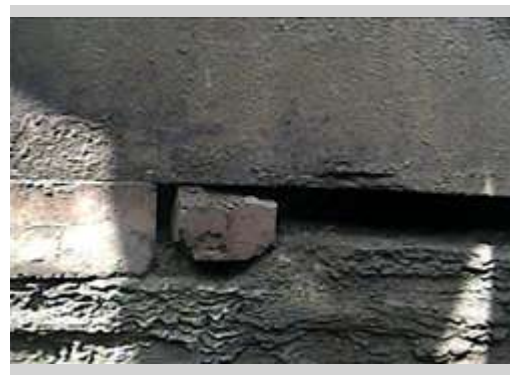
Defect

Condition: ☐ Sound ☐ Cracked ☐ Root Intrusion ☒ **Loose Brick** ☒ **Deteriorated**

Infiltration: ☐ None ☒ **Joint** ☐ Cracks ☒ **Mortar** ☐ Roots ☐ Wall

Frame leaks. Adjustment deterioration,  
loose brick and infiltration.

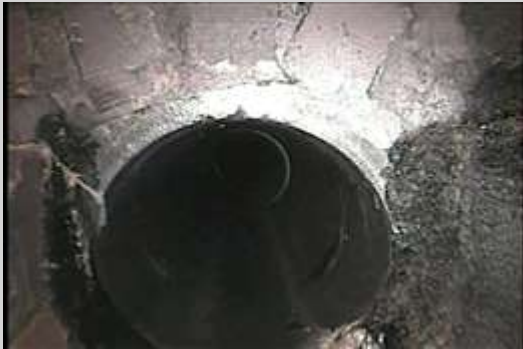
### 10 in. Circular Gravity Sewer Pipe Out @ 12 O'Clock

Deposits: ☐ None ☐ Mud ☐ Sludge ☐ Debris ☒ Grease

Infiltration: **Evidence** Pipe Seal Cond: **Cracked**

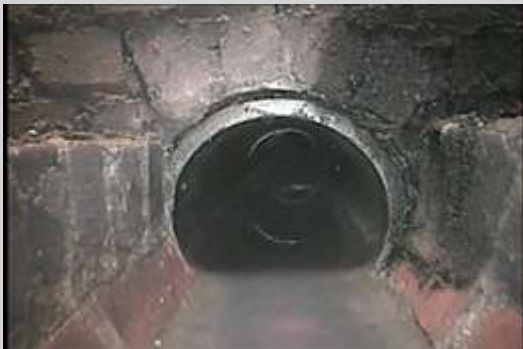
### 10 in. Circular Gravity Sewer Pipe In @ 6 O'Clock

Barrel deterioration and infiltration.

Deposits: ☐ None ☐ Mud ☐ Sludge ☒ Debris ☒ Grease

Infiltration: **Evidence** Pipe Seal Cond: **Cracked**
